TSAWWASSEN FIRST NATION scowaθon mosteyox^w

Drinking Water Quality Monitoring Report 2017

August 2018

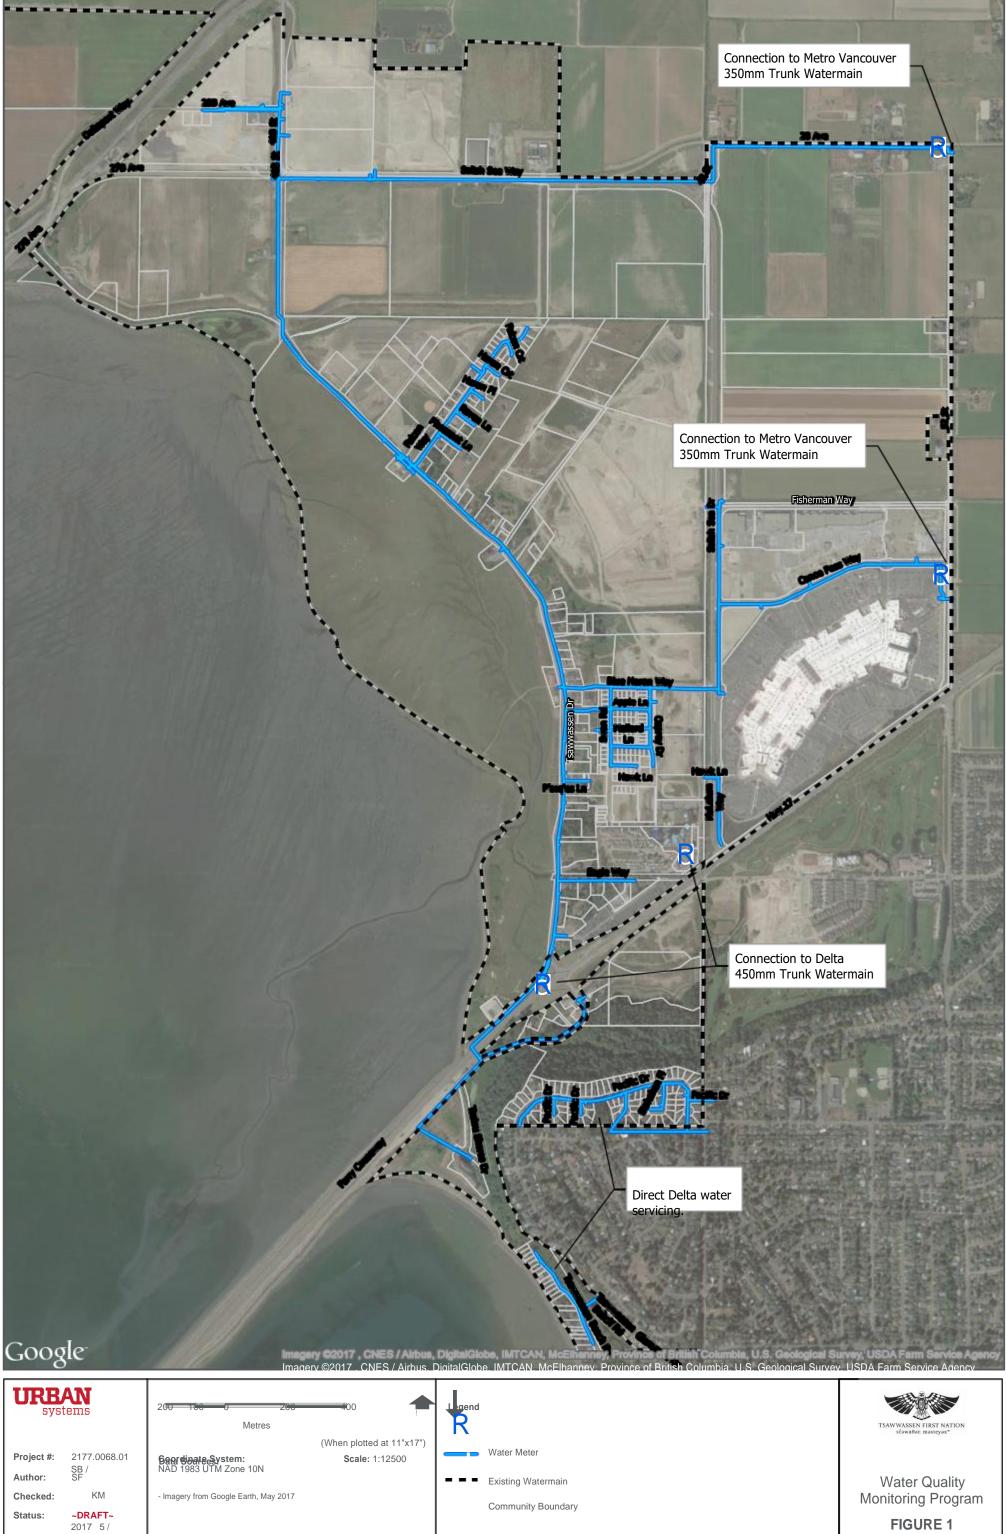
FIGURE 1

An overview drawing of the existing TFN water distribution system is available in **Appendix B**. The system services residential, commercial, and operations sites located on TFN lands, most of which are north of Highway 17. Water quality is monitored at seven different sampling sites throughout the distribution system network.

Water is supplied to TFN by Metro Vancouver and the Corporation of Delta. Two connections to the Metro Vancouver South Delta Main #1 350mm trunk watermain are located along 52 Street, one at 28 Ave and another at Canoe Pass Way. These connections are the primary sources for TFN's distribution system. Two additional connections to a 450mm trunk main owned by Delta are located on Highway 17. The connection south of Salish Sea Dr. services the Big Splash Waterpark, while the connection at Tsawwassen Drive north of Highway 17 is a backup connection that is not typically used. There are also two areas where TFN is directly serviced by Delta's water system located at Pacific Dr. and Tsawwassen Beach Rd. These areas serviced directly by Delta are not part of this monitoring report as the operation and maintenance of these areas is provided by the Corporation of Delta.

The main distribution system is comprised of pipes ranging in size from 150 mm diameter to 500 mm diameter and consists of PVC and HDPE materials.

Existing Water System

The following modifications were completed to the water distribution system in 2017. Details of the current water system is outlined in the Figure in **Appendix B**.

Sampling locations are distributed in different areas throughout TFN so as to obtain an accurate overview of water quality of the distribution system. A system map is available in **Appendix B**.
